**INVESTIGATING THE EFFECTS OF CORROSION ON THE FATIGUE LIFE
OF STEEL**

A Major Report

Major Subject: Civil Engineering

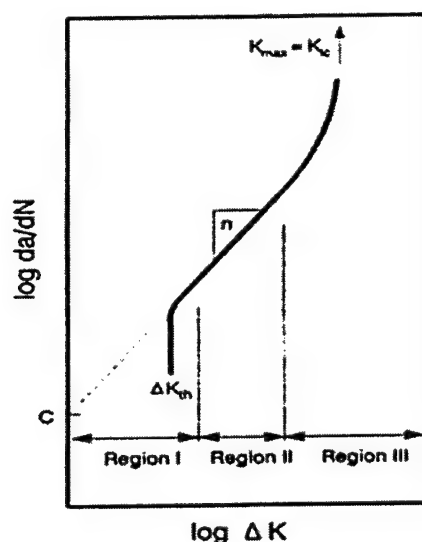
Figure 1. Fatigue crack growth vs. stress intensity factor range

This plot, which is independent of material strengths, reveals three distinct regions of different relationships. At lower values of crack propagation rate, there exists a threshold level, ΔK_{th} , below which the fatigue crack does not propagate. This behavior is represented as Region I. Beyond this threshold, crack propagation occurs at different rates. Within Region II the plot reveals a linear correlation between ΔK and da/dN . This demonstrates the Paris power law where the fatigue crack propagation behavior can be represented as:

where A and m are constants. Region III realizes an asymptotic increase of da/dN as K_{max} approaches the fracture toughness, K_{IC} .

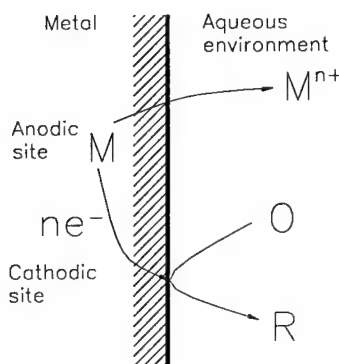
Handbook, 1987). These two reactions take place on two distinct sites on the same surface as shown in Figure 2 (ASM Metals Handbook, 1987).

Figure 2. Schematic of corrosion process

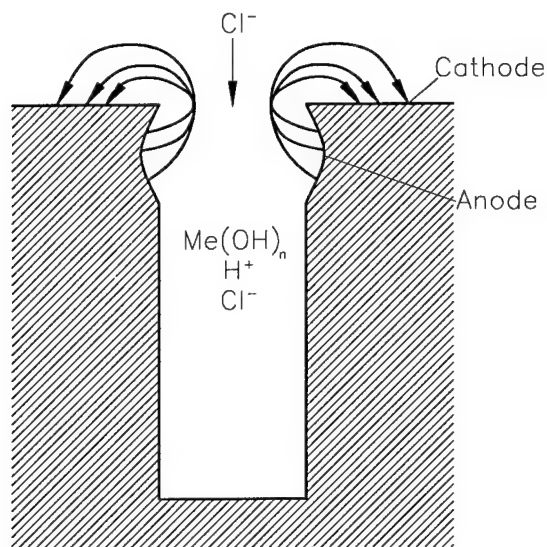
Crevice corrosion will be a specific process expected in a specimen with a notched area. This type of corrosion can exist when the area of a small surface notch differs in environmental conditions. The geometry of a notch shields the immediate area from circulating fluid and allows for the stagnation of the immediate notch environment. Under such stationary conditions, the pH can decrease and the concentration of chloride can increase both resulting in higher corrosivity inside of the notch than outside. Anodic

The phenomenon of crevice corrosion helps explain the greater corrosion losses at the notch than at the specimen surface.

Figure 3. Crevice corrosion

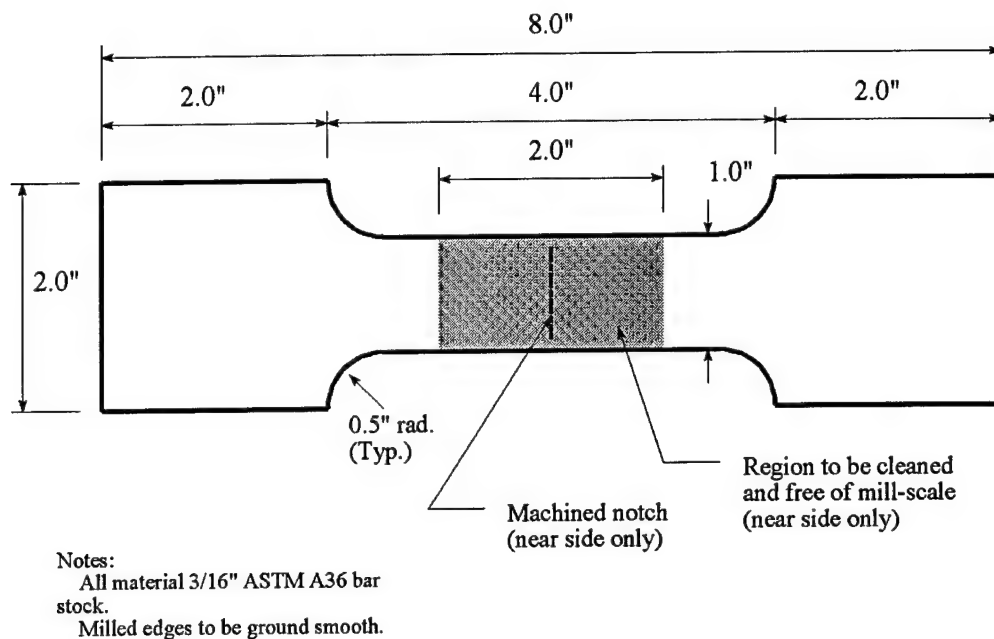
Steel tension specimens, fabricated from ASTM A36 3/16" X 2" bar stock, were used. The geometry of all specimens tested were identical to that presented in Figure 4. The notch in the center of the specimen was used to induce a stress concentration with a reproducible fatigue strength. This notch was machined to a depth of 1/32nd of an inch with a groove angle of 40 degrees. The area around the notch was sandblasted to remove the mill scale and isolate the corrosion process to a confined area.

Figure 4. Specimen geometry

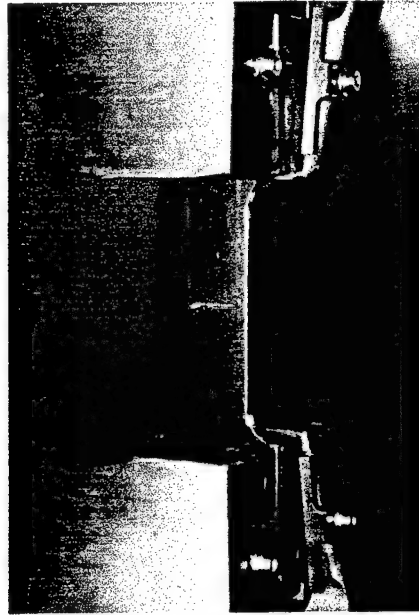
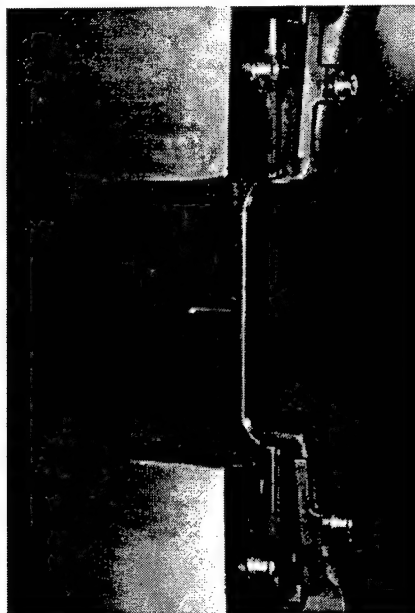
Three specimens, one from each 20 foot length of bar stock, were tested in tension (see Figure 5) to determine the yield and ultimate strengths of the steel. The plotted stress-strain results of these tests are presented as Figure 6. As indicated by the stress-strain plots in Figure 6, specimens B & C showed similar stress-strain behavior. It was assumed that similar stress-strain behavior is indicative of similar chemical characteristics. The bar stock for these two specimens were used to fabricate all of the corrosion specimens used in the test program. The specimens exhibited yield strengths of

Figure 5. Specimen in tension

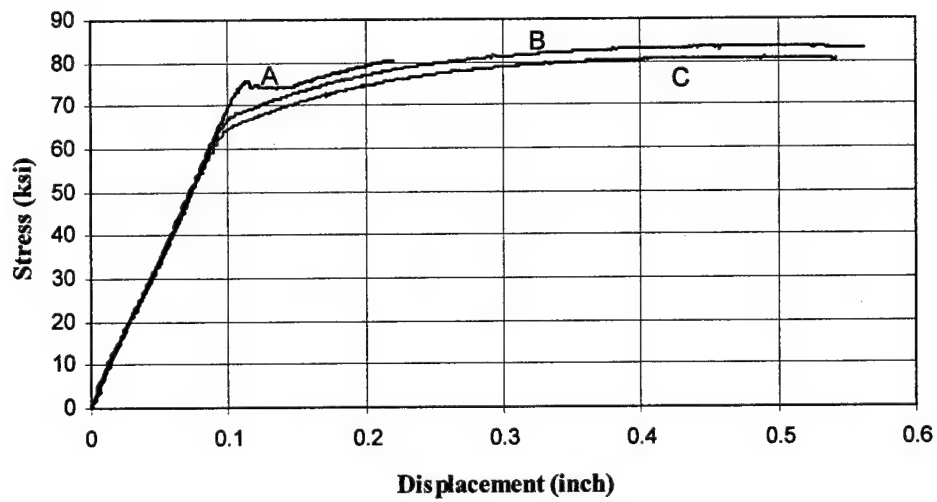
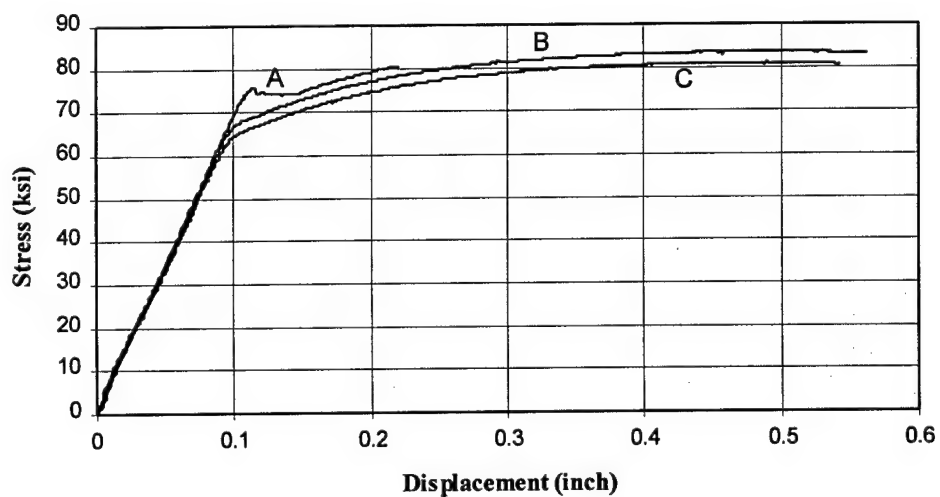
approximately 60 ksi, much higher yield than their 36ksi designation, and an ultimate strength of over 80 ksi.

Figure 6. Yield test results

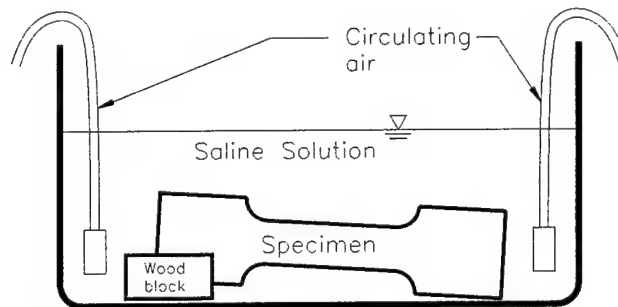
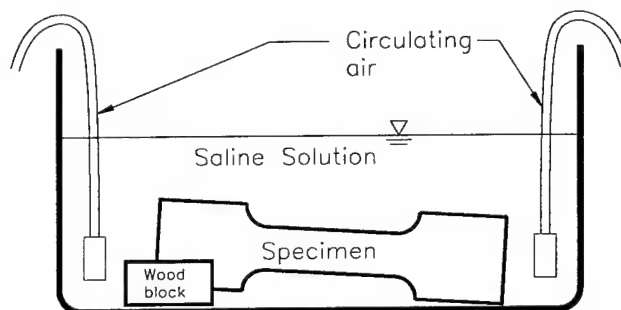
Twenty-four specimens comprised the test groups. These specimens were subjected to accelerated corrosion in a salt water bath. For each of two specimen groups, two gallons of distilled water were converted to a 3.5% salt solution by weight through the addition of 0.58 pounds of sodium chloride (NaCl), an environment similar to clean seawater (Mattsson 1989). This solution was thoroughly mixed and continually aerated and agitated with the assistance of a small aquarium air pump. The diagram in Figure 7 and the photograph in Figure 8 illustrate the set-up of the corrosive environment.

Figure 7. Set-up of corrosive environment

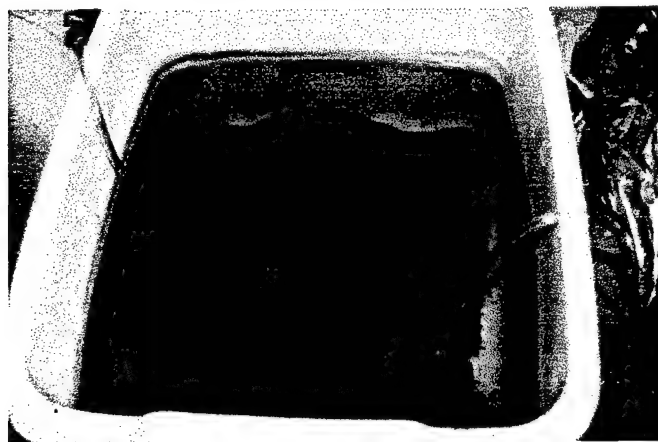
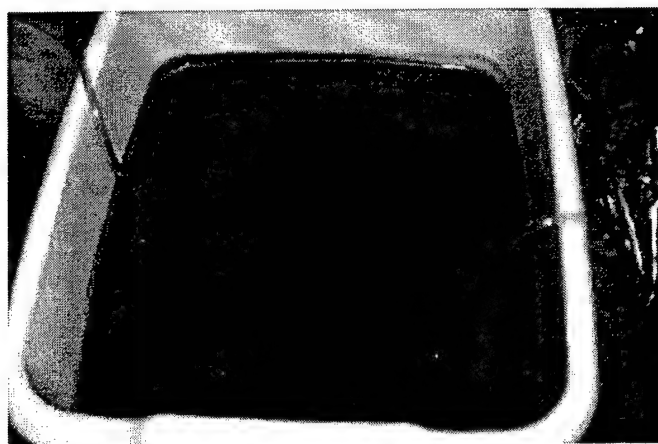
Figure 8. View of experimental set-up

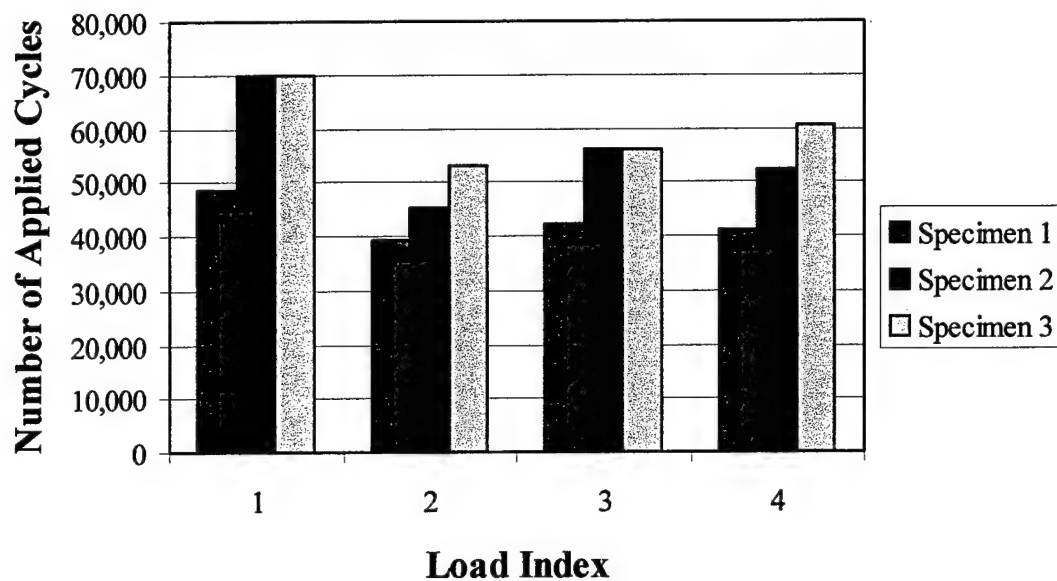
Figure 9. Fatigue life results for Exposure Index 1

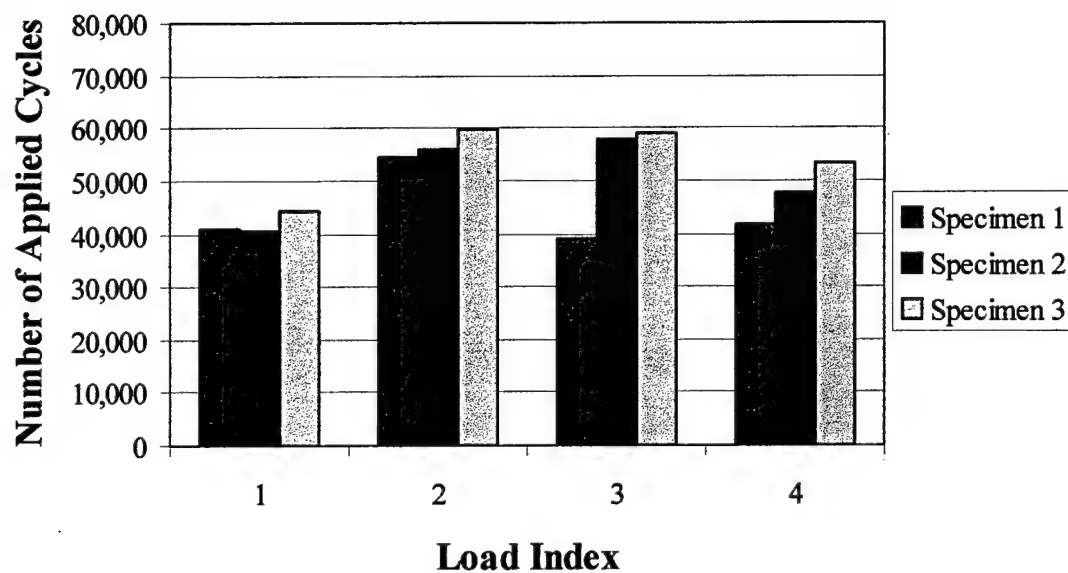
Figure 10. Fatigue life results for Exposure Index 2

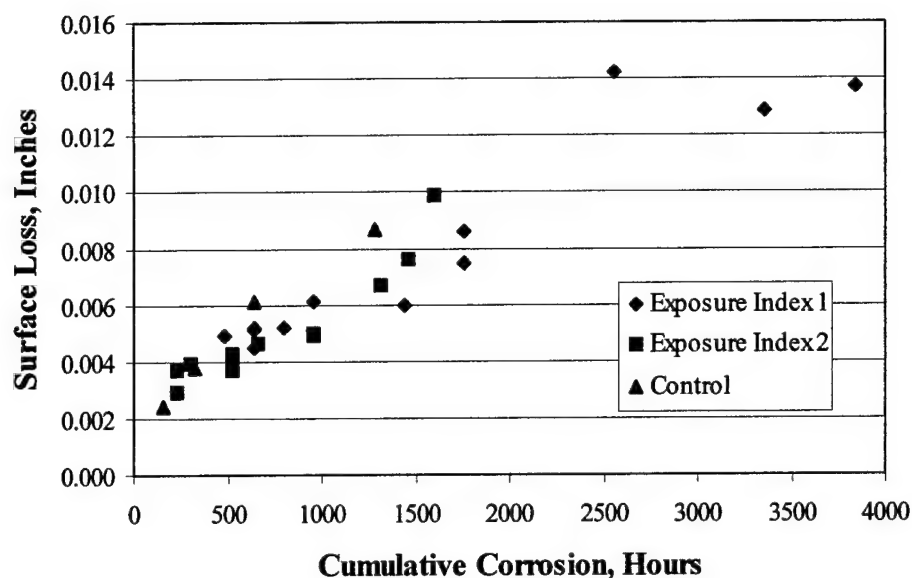
Figure 11. Corrosion rates

Figure 11 graphically presents the corrosion rates of the different exposure indices. As total corrosion exposure increases, there appears to be a decrease in the corrosion rates.

Corrosion rate can be determined by comparing corroded cross sections of members to their noncorroded cross sections. These measurements were taken at flat surface areas as well as within the notch. Due to the nature of failure, however, corrosion rates at the notch for failed members are not available. The section losses and corresponding cumulative corrosion times are presented below in Table 7 and Figure 11.

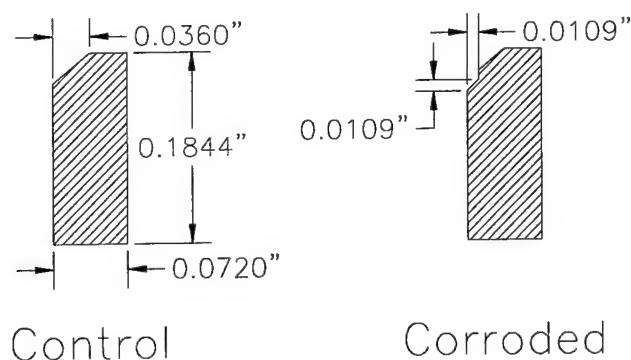
The determination of stresses at the notch of this steel specimen can be accomplished using a finite element model and computer processing using ABAQUS and PATRAN. In order to do this, some simplifications and some approximations must be made to model the system. The geometry of the specimen as entered into ABAQUS and PATRAN is presented below as Figures 20 and 21. Using symmetry, only one half of the specimen must be analyzed from the centerline of the notch. The modeled specimen measured only 0.0720" from the centerline of the notch. At this point, it is safe to assume that the stress distribution returned to nearly uniform and is of not consequence when focusing on the notch. The modeled specimen height (0.1844") corresponds to the uncorroded thickness of Control Specimen 4 and is more accurate than the nominal 3/8" thickness. The thickness of the member into the page was taken as a "unit" thickness of 0.01" to represent any point of the specimen along the notch. Two geometries, each with 3150 elements, were considered representing the specimen before exposure to the corrosive environment and after 8 weeks of exposure. These elements were eight-noded quadratic elements. Only the corrosion at the notch was accounted for in the FEM computer model. The difference in surface thickness can be readily computed by hand and applied to the results.

Figure 20. FEM geometries

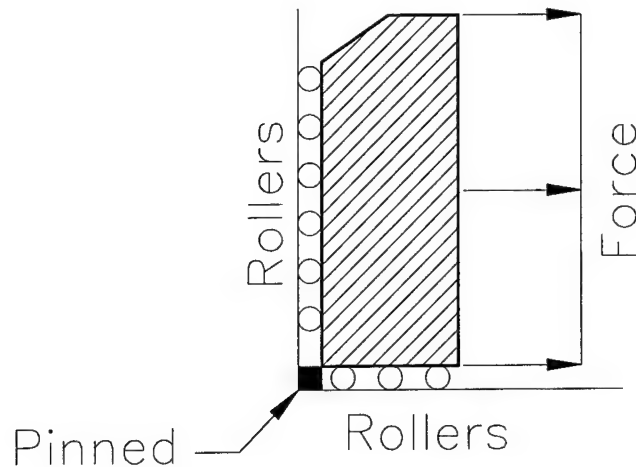
The member is modeled as having roller boundary restraints at the left edge—the interface of specimen symmetry. It is not allowed to deflect horizontally, but it is allowed to deflect vertically. This provides the specimen with the capability of necking due to the axial load. A pinned connection at the lower left corner maintains static equilibrium. Since the vertical “centroids” of the applied force and resistance are not equal, a moment is created. Unrestrained, the right end of the specimen model will deflect vertically from this resultant moment. If the entire specimen had been represented, equilibrium would have balanced these non-concentric forces. Since only one side is modeled, it is necessary to impose boundary conditions to simulate total equilibrium. This is accomplished by providing rollers to the bottom of the specimen to keep it from deflecting vertically (Figure 21). A 1000 pound/in distributed load was applied to the right side. This also provides for easy manipulation of the results.

Figure 21. FEM boundary conditions
